**Flood Control Project Maintenance  
Levee Inspections**

**Fall 2019 Levee Maintenance Deficiency Summary Report**

**Sacramento River Basin**

**Sacramento Maintenance Yard Maintenance Area 0009**

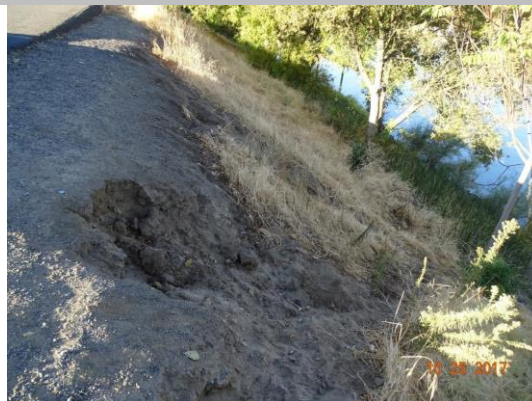
Photo 1 of 1 : FA\_2019\_MA0009\_201\_298\_20190904\_00201.jpg

LM Start	0.38	Rating **	M	Issue No.	298
LM End	0.38	Issue Type +	Ma	Location *	WS
Category	Earthen Levee			GPS Latitude/Longitude	
				Start	End
Item	Erosion / Bank Caving			38.536712 °	38.536712 °
				-121.515757 °	-121.515757 °
DWR ID	DWR_MA0009_01_f_2017_298				
Comment Code					
E2 : Schedule repair of erosion site prior to the next inspection.					
Inspector Comment					
Repair footpath that is beginning to erode further from runoff.

View of erosion on waterside slope. Fall 2017.

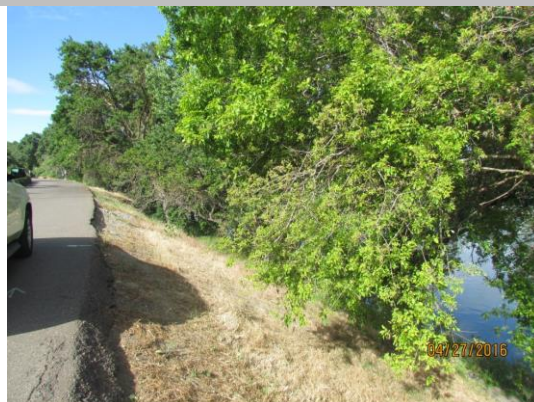
Photo 1 of 1 : FA\_2019\_MA0009\_201\_281\_20190904\_00195.jpg

LM Start	0.40	Rating **	M	Issue No.	281
LM End	0.40	Issue Type +	Ma	Location *	WS
Category	Earthen Levee			GPS Latitude/Longitude	
				Start	End
Item	Trim / Thin Trees			38.536556°	38.536556°
				-121.515990°	-121.515990°
DWR ID	DWR_MA0009_01_f_2015_281				
Comment Code					
T1 : Trim trees to at least five feet above ground level.					
Inspector Comment

View of the trees on the waterward side of the levee looking downstream. Spring 2016.

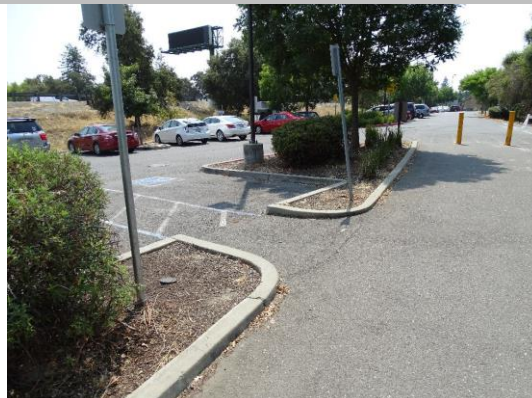
Photo 1 of 3 : UCIP\_FA\_2019\_53466\_77893.jpg

LM Start	<b>0.46</b>	Rating **	M	Issue No.	<b>1769 (cont)</b>
LM End	<b>0.46</b>	Issue Type +	En	Location *

LS view.

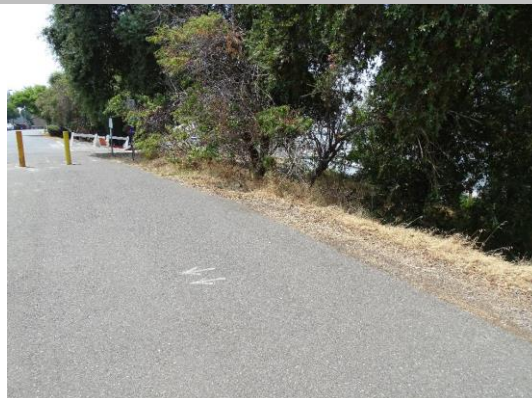
Photo 2 of 3 : UCIP\_FA\_2019\_53466\_77894.jpg

WS view.

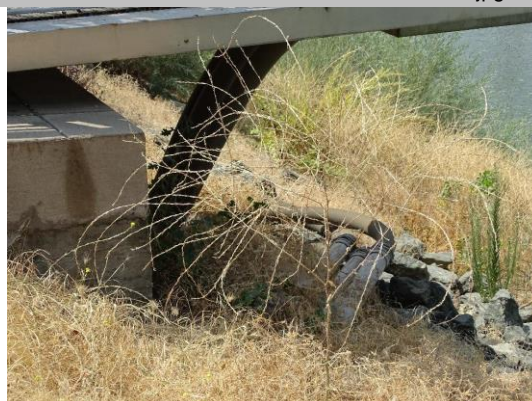
Photo 3 of 3 : UCIP\_FA\_2019\_53466\_77895.jpg

Comment Code						
Inspector Comment						
DS_ID:17404 FS_ID:53466 EP_NO: 2536 Repair Type: Non-Urgent Crossing Status: Not Found UCIP Comments: 09/04/2018 Original permit indicates that there is a gas line near here. I can't find any evidence or markers to indicate that there is a gas line. Current PG&E records do not indicate that there are any PG&E gas pipelines located in this area. Crossing has been downgraded to "Non-Urgent" pending that there is an electromagnetic survey conducted by DWR DMP Phase 1. (A. McDonald - DWR UCIP)08/24/2018 Unable to locate any gas lines or markers near this location. (A. McDonald - DWR UCIP)08/11/2017 PG&E records do not indicate that there are any PG&E gas pipelines near this location. (A. McDonald - DWR UCIP)12/02/2016 same as last inspection unable to locate line. Need to coordinate with PG&E to determine status of crossing. (O. Magana - DWR UCIP)06/19/2012 Gas line should be located if possible. May require use of a metal detector. (W. Wylie - DWR UCIP) FIELD_STRUCT_DESC: 2-inch (1.5-inch listed in permit) gas line of an unknown material through the levee, 3 feet below the crown. Line connects from Riverside Boulevard and West Coast Drive on the landside (LS), continues across the levee, and runs parallel along the waterside (WS) slope for about 411 feet. (1.5-inch gas line service authorized under Permit No. 2536, 1957 - Pacific Gas and Electric Company [PG&E]). [Additional Reference(s): DWR Levee Log, 1991]. FS Date: 9/4/2018

Pipes visible underneath the walkway to the dock.

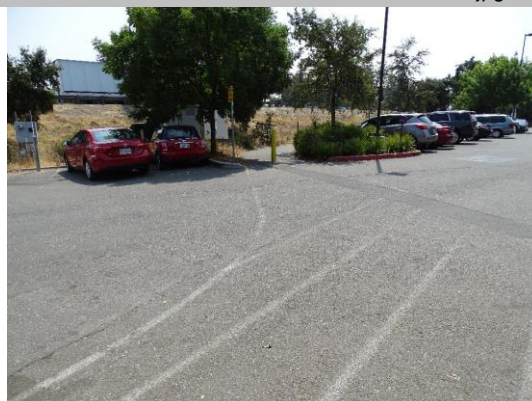
Photo 1 of 3 : UCIP\_FA\_2019\_53467\_77890.jpg

LM Start	<b>0.47</b>	Rating **	M	Issue No.	<b>1770 (cont)</b>
LM End	<b>0.47</b>	Issue Type +	En	Location *

LS view.

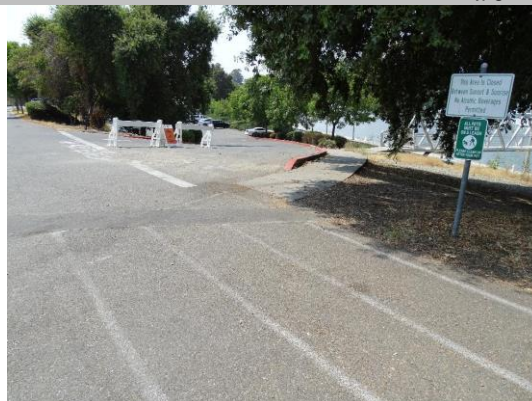
Photo 2 of 3 : UCIP\_FA\_2019\_53467\_77891.jpg

WS view.

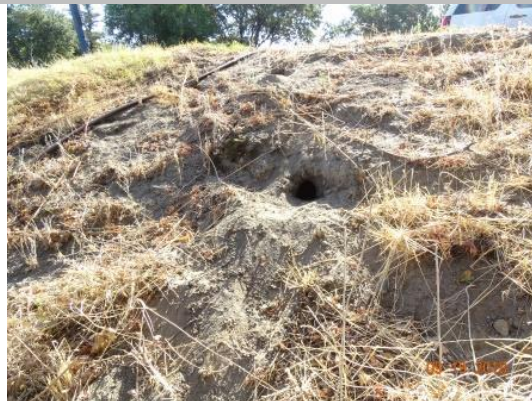
Photo 1 of 1 : FA\_2019\_MA0009\_201\_282\_20190904\_00196.jpg

LM Start	0.53	Rating **	M	Issue No.	282
LM End	0.53	Issue Type +	Ma	Location *	WS
Category	Earthen Levee			GPS Latitude/Longitude	
				Start	End
Item	Animal Control			38.534930 °	38.534930 °
				-121.517314 °	-121.517314 °
DWR ID	DWR_MA0009_01_f_2015_282				
Comment Code					
A3 : No rodents visible, but rodent burrows visible; need to backfill and compact or grout burrows.					
Inspector Comment					
Backfil rodent hole.

View of rodent holes on waterside of levee. Fall 2018

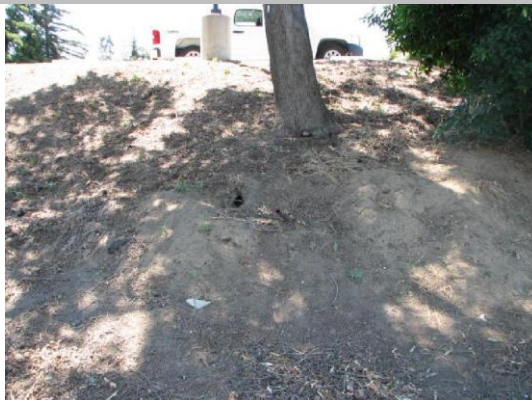
Photo 1 of 2 : UCIP\_FA\_2019\_47076\_8695.jpg

LM Start	0.55	Rating **	M	Issue No.	1771
LM End	0.55	Issue Type +	En	Location *	
Category	Supplemental			GPS Latitude/Longitude	
				Start	End
Item	DRAFT DWR UCIP Field Study			38.534830 °	38.534830 °
				-121.517530 °	-121.517530 °
DWR ID	18890				
Comment Code					
Inspector Comment					
DS_ID:18890					
FS_ID:47076					
EP_NO: N/A					
Repair Type: Non-Urgent					
Crossing Status: Found					
UCIP Comments: Pipe is open on WS and may need to be removed or Abandoned in place. Only WS of pipe could be seen.					
FIELD_STRUCT_DESC: 1-inch steel pipe of an unknown purpose through the levee, 10 feet below the crown.					
FS Date: 6/19/2012 2:51:00 PM

Pipe exiting bank just below tree at center of photo on WS slope.

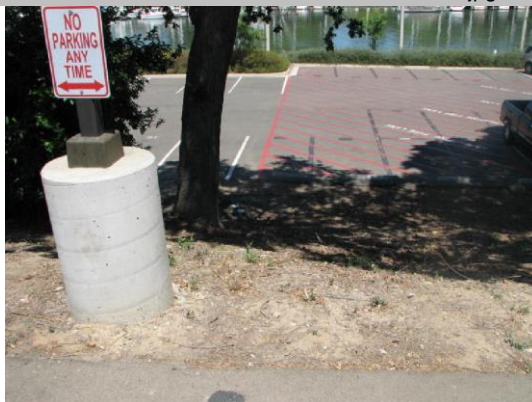
Photo 2 of 2 : UCIP\_FA\_2019\_47076\_8694.jpg

View from WS shoulder. Pipe is at bottom right of tree on WS bank.

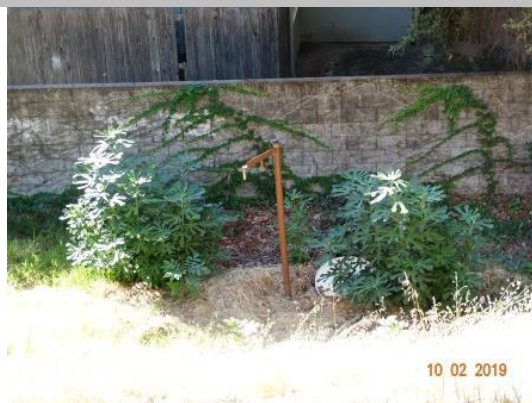
Photo 1 of 1 : FA\_2019\_MA0009\_201\_164\_20191008\_00510.jpg

LM Start	0.76	Rating **	M	Issue No.	164
LM End	0.76	Issue Type +	En	Location *	LS
Category	Earthen Levee			GPS Latitude/Longitude	
				Start	End
Item	Encroachments			38.533538 °	38.533538 °
				-121.521168 °	-121.521168 °
DWR ID	DWR_MA0009_01_f _ 2019_164				
Comment Code					
PO : Pole					
Inspector Comment					
Remove metal pole at landside toe.

View of metal pole at the landside toe. Fall 2019

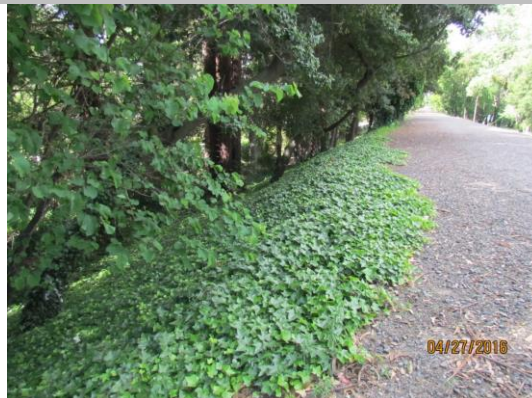
Photo 1 of 1 : FA\_2019\_MA0009\_201\_10\_20190904\_00002.jpg

LM Start	0.79	Rating **	M	Issue No.	10
LM End	0.81	Issue Type +	En	Location *	LS
Category	Earthen Levee			GPS Latitude/Longitude	
				Start	End
Item	Vegetation			38.533348°	38.533207°
				-121.521576°	-121.521916°
DWR ID	DWR_MA0009_01_f_2016_10				
Comment Code					
V6 : Landscaping					
Inspector Comment					
Groundcover obstructs visibility.

View of the vegetation on the landward side of the levee looking downstream. Spring 2016.

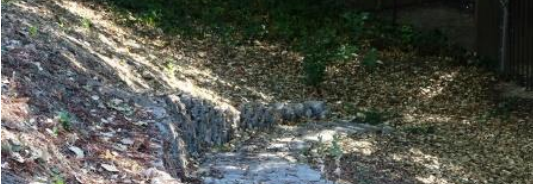
Photo 1 of 2 : FA\_2019\_MA0009\_201\_242\_20191008\_00511.jpg

View of concrete blocks added to a footpath. Fall 2019

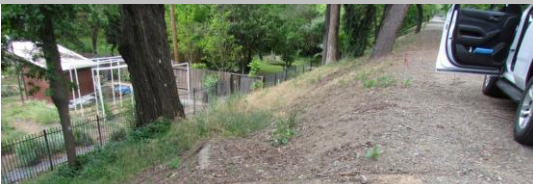
Photo 1 of 1 : FA\_2019\_MA0009\_2013\_20190904\_00003.jpg

View of the Footpath that cuts into the levee slope on the landward side looking downstream. Spring 2016.

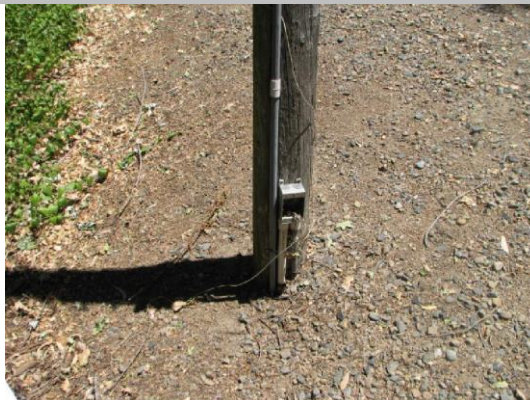
Photo 2 of 2 : UCIP\_FA\_2019\_41534\_6103.jpg

LM Start	0.85	Rating **	M	Issue No.	1772 (cont)
LM End	0.85	Issue Type +	En	Location *	
Category	Supplemental			GPS Latitude/Longitude	
				Start	End
Item	DRAFT DWR UCIP Field Study			38.532930 °	38.532930 °
				-121.522610 °	-121.522610 °
DWR ID	17407				
Comment Code					
Inspector Comment					
DS_ID:17407 FS_ID:41534 EP_NO: N/A Repair Type: Non-Urgent Crossing Status: Found UCIP Comments: Appears abandoned. FIELD_STRUCT_DESC: 1.5-inch electrical conduit of an unknown material through the levee, at an unknown depth. Pole on the waterside (WS) slope. [Additional Reference(s): DWR Levee Log, 1991]. FS Date: 6/19/2012 7:58:00 AM

Electrical conduit at bottom of pole on water side.

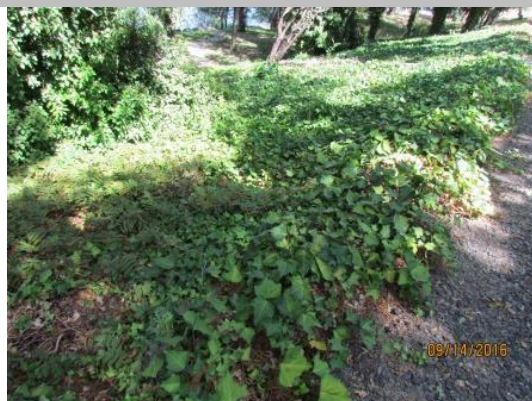
Photo 1 of 2 : FA\_2019\_MA0009\_201\_292\_20190904\_00198.jpg

LM Start	0.87	Rating **	U	Issue No.	292
LM End	0.92	Issue Type +	En	Location *	WS
Category	Earthen Levee			GPS Latitude/Longitude	
				Start	End
Item	Vegetation			38.532847 °	38.532504 °
				-121.522872 °	-121.523770 °
DWR ID	DWR_MA0009_01_f_2016_292				
Comment Code					
V6 : Landscaping					
Inspector Comment					
Groundcover is obstructing visibility.

Landscaping on waterward slope. Fall 2016 inspection.

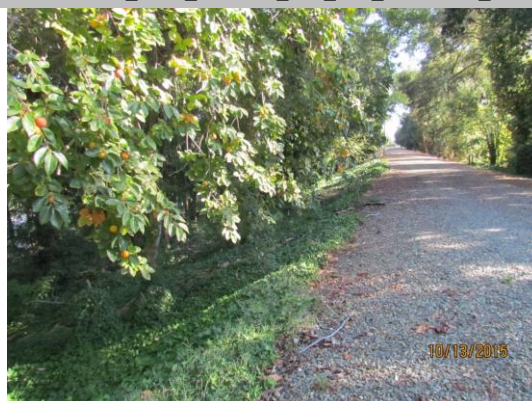
Photo 2 of 2 : FA\_2019\_MA0009\_201\_292\_20190904\_00199.jpg

View of the landscaping on the waterward side of the levee looking upstream. Fall 2015.

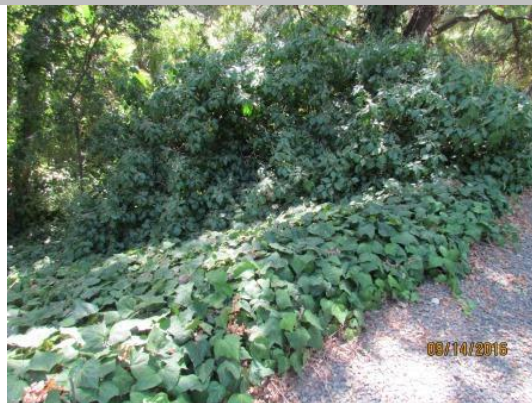
Photo 1 of 2 : FA\_2019\_MA0009\_201\_15\_20190904\_00004.jpg

LM Start	0.88	Rating **	U	Issue No.	15
LM End	0.90	Issue Type +	En	Location *	LS
Category	Earthen Levee			GPS Latitude/Longitude	
				Start	End
Item	Vegetation			38.532730°	38.532628°
				-121.523129°	-121.523406°
DWR ID	DWR_MA0009_01_s_2012_15				
Comment Code					
V6 : Landscaping					
Inspector Comment					
Trees are obstructing view and need to be trimmed.

Groundcover on landside slope. Fall 2016 inspection.

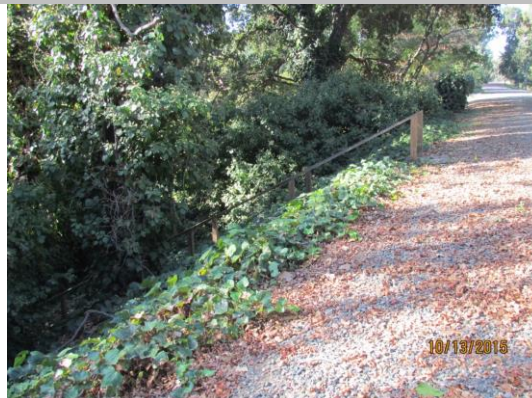
Photo 2 of 2 : FA\_2019\_MA0009\_201\_15\_20190904\_00005.jpg

LM Start	0.88	Rating **	U	Issue No.	15 (cont)	
LM End	0.90	Issue Type +	En	Location *	LS	
Category	Earthen Levee			GPS Latitude/Longitude		
				Start		End
Item	Vegetation			38.532730 °		38.532628 °
				-121.523129 °		-121.523406 °
DWR ID	DWR_MA0009_01_s_2012_15					
Comment Code						
V6 : Landscaping						
Inspector Comment						
Trees are obstructing view and need to be trimmed.

View of the groundcover and trees on the landward side of the levee looking downstream. Fall 2015.

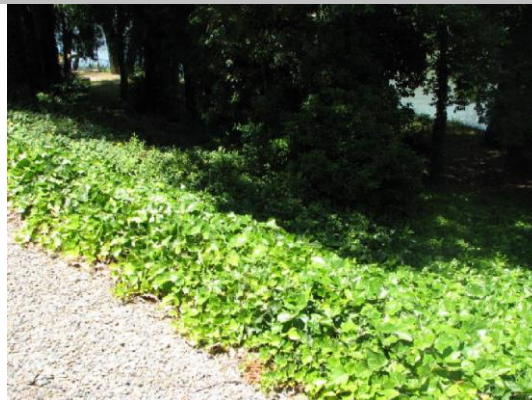
Photo 1 of 2 : UCIP\_FA\_2019\_40523\_6122.jpg

LM Start	0.90	Rating **	M	Issue No.	1773	
LM End	0.90	Issue Type +	En	Location *		
Category	Supplemental			GPS Latitude/Longitude		
				Start	End	
Item	DRAFT DWR UCIP Field Study			38.532640 °	38.532640 °	
				-121.523370 °	-121.523370 °	
DWR ID	17727					
Comment Code						
Inspector Comment						
DS_ID:17727						
FS_ID:40523						
EP_NO: 4809						
Repair Type: Non-Urgent						
Crossing Status: Indicator Found						
UCIP Comments: Could not locate service box due to excessive vegetation (see Pics) Possible electrical conduit crossing at this same location.						
FIELD_STRUCT_DESC: 3/4-inch domestic water supply with valve on land side.						
FS Date: 6/19/2012 2:00:00 PM

Excessive vegetation on waterside.

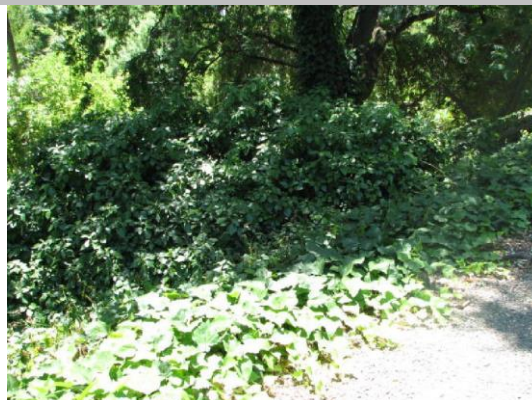
Photo 2 of 2 : UCIP\_FA\_2019\_40523\_6121.jpg

Excessive vegetation on landside.

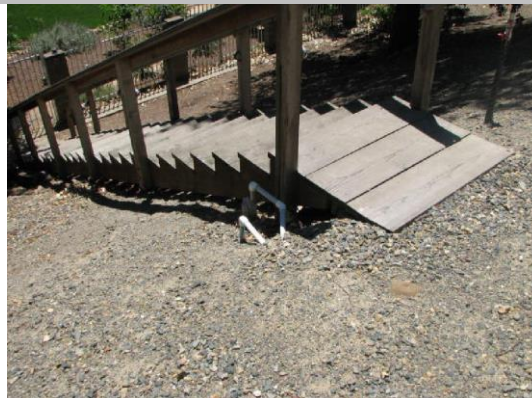
Photo 1 of 2 : UCIP\_FA\_2019\_5842\_8908.jpg

LM Start	0.94	Rating **	M	Issue No.	1774
LM End	0.94	Issue Type +	En	Location *	
Category	Supplemental			GPS Latitude/Longitude	
				Start	End
Item	DRAFT DWR UCIP Field Study			38.532380 °	38.532380 °
				-121.524080 °	-121.524080 °
DWR ID	18896				
Comment Code					
Inspector Comment					
DS_ID:18896					
FS_ID:5842					
EP_NO: N/A					
Repair Type: Non-Urgent					
Crossing Status: Found					
UCIP Comments: No permit identified for this crossing. Pipe located 1-foot upstream of stairs on LS slope.					
FIELD_STRUCT_DESC: 0.75-inch electrical conduit of an unknown material through the levee, 1 foot below the crown.					
FS Date: 6/19/2012 9:19:25 AM

Electrical conduit on LS slope just upstream of stairs.

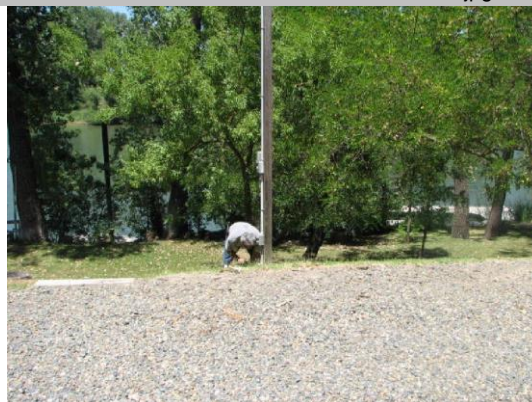
Photo 2 of 2 : UCIP\_FA\_2019\_5842\_8907.jpg

Light on Post WS slope at crossing.

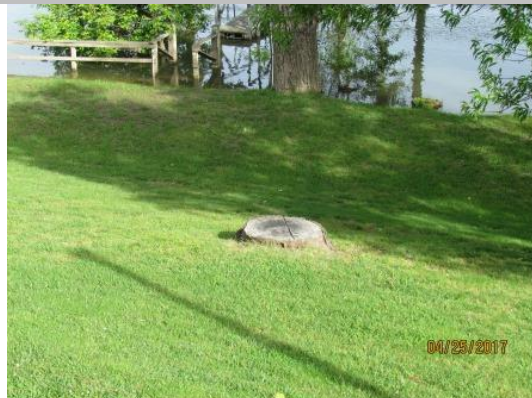
Photo 1 of 1 : FA\_2019\_MA0009\_201\_237\_20190904\_00157.jpg

LM Start	0.94	Rating **	N	Issue No.	237
LM End	0.94	Issue Type +	Ma	Location *	WS
Category	Earthen Levee			GPS Latitude/Longitude	
				Start	End
Item	Trim / Thin Trees			38.532357°	38.532357°
				-121.524112°	-121.524112°
DWR ID	DWR_MA0009_01_s_2017_237				
Comment Code					
T5 : Tree stumps.					
Inspector Comment

View of stump on waterside slope. Spring 2017.

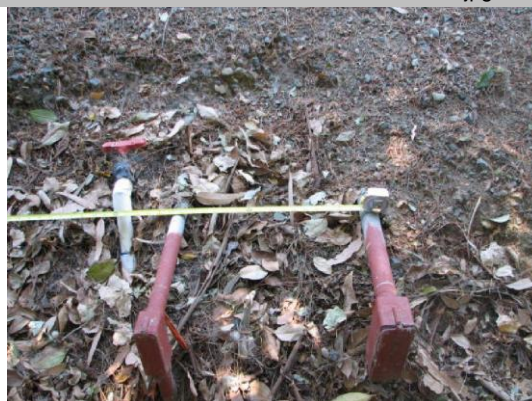
Photo 1 of 3 : UCIP\_FA\_2019\_5844\_8914.jpg

DS\_ID:18897  
 FS\_ID:5844  
 EP\_NO: N/A  
 Repair Type: Non-Urgent  
 Crossing Status: Found  
 UCIP Comments: No permit identified for this crossing.  
 FIELD\_STRUCT\_DESC: 1-inch polyvinyl chloride (PVC) electrical conduit through the levee, 1.5 feet below the crown. Light on pole next to irrigation box on the waterside (WS) shoulder.  
 FS Date: 6/19/2012 9:30:37 AM

Pipes visible on LS slope.

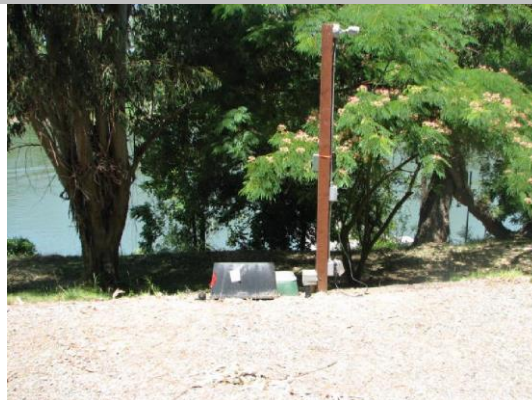
Photo 3 of 3 : UCIP\_FA\_2019\_5844\_8912.jpg

LM Start	0.98	Rating **	M	Issue No.	1776 (cont)
LM End	0.98	Issue Type +	En	Location *	
Category	Supplemental			GPS Latitude/Longitude	
				Start	End
Item	DRAFT DWR UCIP Field Study			38.532150 °	38.532150 °
				-121.524660 °	-121.524660 °
DWR ID	18897				
Comment Code					
Inspector Comment					
DS_ID:18897					
FS_ID:5844					
EP_NO: N/A					
Repair Type: Non-Urgent					
Crossing Status: Found					
UCIP Comments: No permit identified for this crossing.					
FIELD_STRUCT_DESC: 1-inch polyvinyl chloride (PVC) electrical conduit through the levee, 1.5 feet below the crown. Light on pole next to irrigation box on the waterside (WS) shoulder.					
FS Date: 6/19/2012 9:30:37 AM

Light on Pole WS slope.

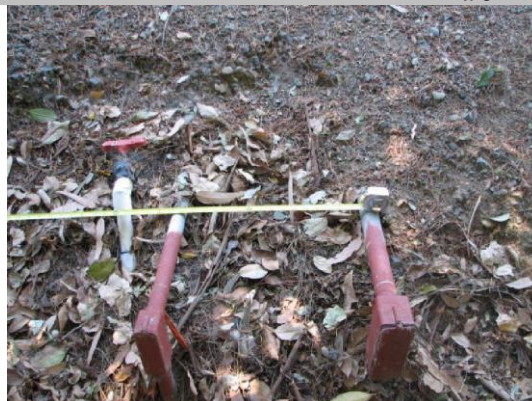
Photo 1 of 2 : UCIP\_FA\_2019\_5845\_8916.jpg

LM Start	0.98	Rating **	M	Issue No.	1777	
LM End	0.98	Issue Type +	En	Location *		
Category	Supplemental			GPS Latitude/Longitude		
				Start	End	
Item	DRAFT DWR UCIP Field Study			38.532150 °	38.532150 °	
				-121.524660 °	-121.524660 °	
DWR ID	18899					
Comment Code						
Inspector Comment						
DS_ID:18899 FS_ID:5845 EP_NO: N/A Repair Type: Non-Urgent Crossing Status: Found UCIP Comments: No permit identified for this crossing. FIELD_STRUCT_DESC: 1-inch polyvinyl chloride (PVC) water line through the levee, 1.5 feet below the crown. Shutoff valve on the landside (LS) shoulder. Light on pole next to irrigation box on the waterside (WS) shoulder. FS Date: 6/19/2012 9:32:28 AM

Pipes with shutoff valve on LS slope.

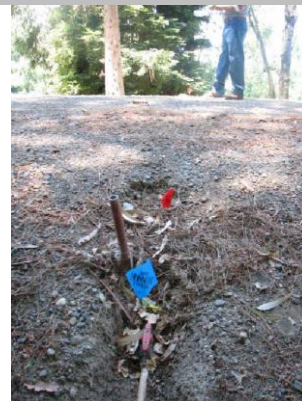
Photo 1 of 1 : UCIP\_FA\_2019\_5846\_8917.jpg

LM Start	0.99	Rating **	M	Issue No.	1778
LM End	0.99	Issue Type +	En	Location *	
Category	Supplemental			GPS Latitude/Longitude	
				Start	End
Item	DRAFT DWR UCIP Field Study			38.532070 °	38.532070 °
				-121.524950 °	-121.524950 °
DWR ID	18900				
Comment Code					
Inspector Comment					
DS_ID:18900					
FS_ID:5846					
EP_NO: N/A					
Repair Type: Non-Urgent					
Crossing Status: Found					
UCIP Comments: No permit identified for this crossing.					
FIELD_STRUCT_DESC: 1-inch polyvinyl chloride (PVC) water line through the levee, 1.5 feet below the crown. Shutoff valve on the landside (LS) shoulder.					
FS Date: 6/19/2012 9:36:43 AM

View of pipe and valve on LS shoulder looking towards WS slope.

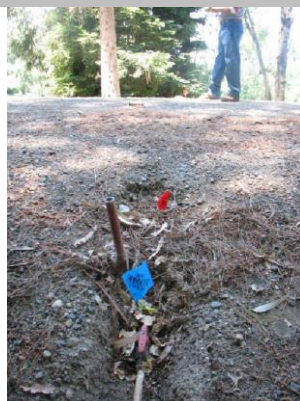
Photo 1 of 1 : UCIP\_FA\_2019\_5847\_8918.jpg

LM Start	0.99	Rating **	M	Issue No.	1779
LM End	0.99	Issue Type +	En	Location *	
Category	Supplemental			GPS Latitude/Longitude	
				Start	End
Item	DRAFT DWR UCIP Field Study			38.532050 °	38.532050 °
				-121.524940 °	-121.524940 °
DWR ID	18901				
Comment Code					
Inspector Comment					
DS_ID:18901					
FS_ID:5847					
EP_NO: N/A					
Repair Type: Non-Urgent					
Crossing Status: Found					
UCIP Comments: No permit identified for this crossing.					
FIELD_STRUCT_DESC: 1-inch polyvinyl chloride (PVC) electrical conduit through the levee, 1.5 feet below the crown. Shutoff valve on the landside (LS) shoulder.					
FS Date: 6/19/2012 9:39:42 AM

Pipes visible on LS shoulder/slope looking towards WS.

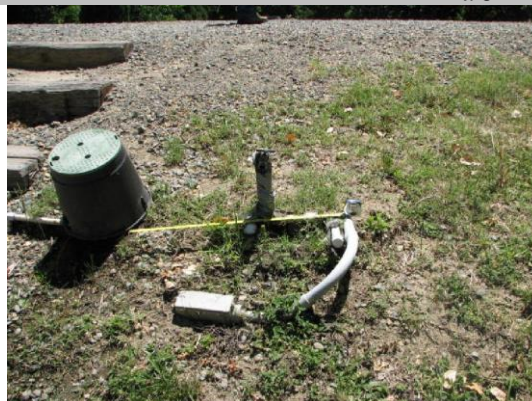
Photo 1 of 3 : UCIP\_FA\_2019\_5848\_8921.jpg

LM Start	1.01	Rating **	M	Issue No.	1780	
LM End	1.01	Issue Type +	En	Location *		
Category	Supplemental			GPS Latitude/Longitude		
				Start	End	
Item	DRAFT DWR UCIP Field Study			38.531970 °	38.531970 °	
				-121.525210 °	-121.525210 °	
DWR ID	18903					
Comment Code						
Inspector Comment						
DS_ID:18903						
FS_ID:5848						
EP_NO: N/A						
Repair Type: Non-Urgent						
Crossing Status: Found						
UCIP Comments: No permit identified for this crossing.						
FIELD_STRUCT_DESC: 0.75-inch polyvinyl chloride (PVC) water line through the levee, 1.5 feet below the crown. Hose bib and electrical box visible on the waterside (WS) shoulder. Pipe visible on the downstream side of the landside (LS) shoulder stairs. (Permit No. 6293, 1968 - William H. Geyer).						
FS Date: 6/19/2012 9:42:01 AM

Hose bib on WS slope downstream 2-feet from stairs.

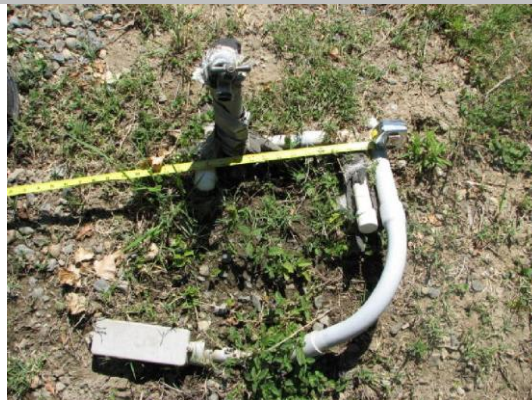
Photo 2 of 3 : UCIP\_FA\_2019\_5848\_8920.jpg

LM Start	1.01	Rating **	M	Issue No.	1780 (cont)	
LM End	1.01	Issue Type +	En	Location *		
Category	Supplemental			GPS Latitude/Longitude		
				Start	End	
Item	DRAFT DWR UCIP Field Study			38.531970°	38.531970°	
				-121.525210°	-121.525210°	
DWR ID	18903					
Comment Code						
Inspector Comment						
DS_ID:18903 FS_ID:5848 EP_NO: N/A Repair Type: Non-Urgent Crossing Status: Found UCIP Comments: No permit identified for this crossing. FIELD_STRUCT_DESC: 0.75-inch polyvinyl chloride (PVC) water line through the levee, 1.5 feet below the crown. Hose bib and electrical box visible on the waterside (WS) shoulder. Pipe visible on the downstream side of the landside (LS) shoulder stairs. (Permit No. 6293, 1968 - William H. Geyer). FS Date: 6/19/2012 9:42:01 AM

Closeup of hose bib.

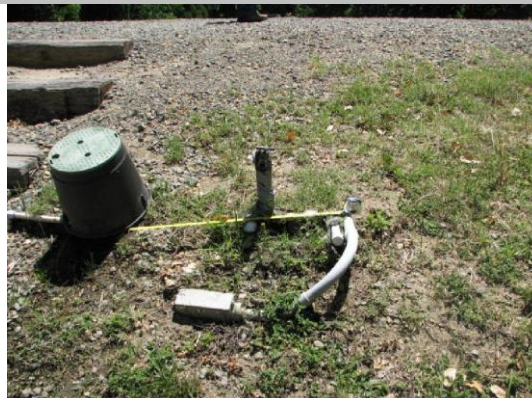
Photo 1 of 2 : UCIP\_FA\_2019\_5849\_8923.jpg

DS\_ID:18902  
FS\_ID:5849  
EP\_NO: N/A  
Repair Type: Non-Urgent  
Crossing Status: Found  
UCIP Comments: No permit identified for this crossing.  
FIELD\_STRUCT\_DESC: 1-inch polyvinyl chloride (PVC) electrical conduit through the levee, 1.5 feet below the crown. Hose bib and electrical box visible on the waterside (WS) shoulder. Pipe visible on the downstream side of the landside (LS) shoulder stairs. (Permit No. 6293, 1968 - William H. Geyer).  
FS Date: 6/19/2012 9:45:10 AM

Electrical conduit on WS slope.

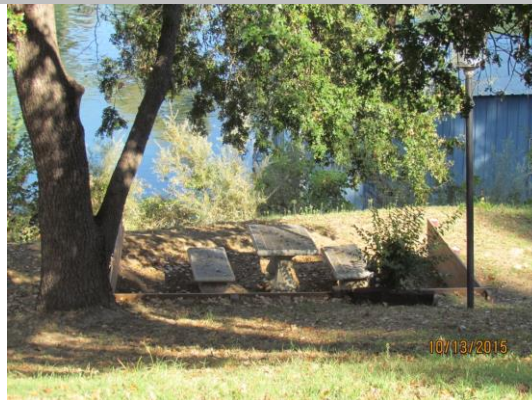
Photo 1 of 1 : FA\_2019\_MA0009\_201\_303\_20190904\_00211.jpg

LM Start	1.01	Rating **	M	Issue No.	303
LM End	1.01	Issue Type +	En	Location *	WS
Category	Earthen Levee			GPS Latitude/Longitude	
				Start	End
Item	Encroachments			38.531959 °	38.531959 °
				-121.525236 °	-121.525236 °
DWR ID	DWR_MA0009_01_f_2015_303				
Comment Code					
RW : Retaining Wall					
Inspector Comment					
Permit 16358 authorizes a wood deck on the waterside berm but not a retaining wall, light post, and picnic area.

View of the table and retaining wall on the waterward side of the levee.  
Fall 2015.

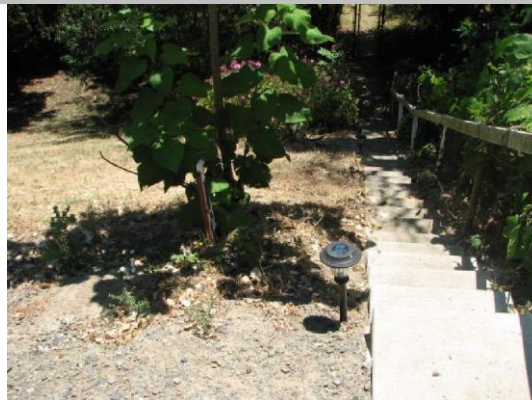
Photo 2 of 3 : UCIP\_FA\_2019\_5850\_8925.jpg

LM Start	1.02	Rating **	M	Issue No.	1782 (cont)	
LM End	1.02	Issue Type +	En	Location *		
Category	Supplemental			GPS Latitude/Longitude		
				Start	End	
Item	DRAFT DWR UCIP Field Study			38.531880°	38.531880°	
				-121.525470°	-121.525470°	
DWR ID	18904					
Comment Code						
Inspector Comment						
DS_ID:18904 FS_ID:5850 EP_NO: N/A Repair Type: Non-Urgent Crossing Status: Found UCIP Comments: No permit identified for this crossing. FIELD_STRUCT_DESC: 1-inch polyvinyl chloride (PVC) water line through the levee, 1.5 feet below the crown. Hose bibs on both the waterside (WS) and the landside (LS) shoulders. T posts mark end of line on both sides of the levee. FS Date: 6/19/2012 9:47:29 AM

Hosebib on LS slope.

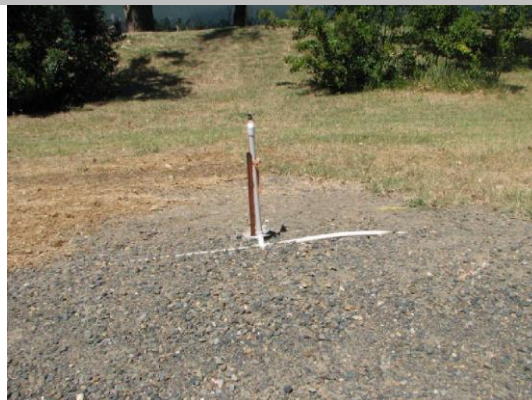
Photo 3 of 3 : UCIP\_FA\_2019\_5850\_8924.jpg

Hosebib on WS slope.

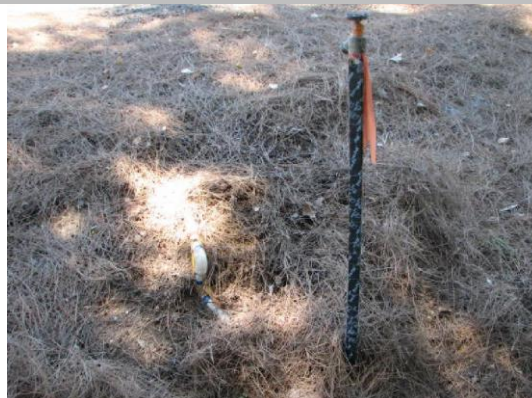
Photo 1 of 3 : UCIP\_FA\_2019\_5851\_8929.jpg

LM Start	1.04	Rating **	M	Issue No.	1783	
LM End	1.04	Issue Type +	En	Location *		
Category	Supplemental			GPS Latitude/Longitude		
				Start	End	
Item	DRAFT DWR UCIP Field Study			38.531750°	38.531750°	
				-121.525810°	-121.525810°	
DWR ID	18905					
Comment Code						
Inspector Comment						
DS_ID:18905						
FS_ID:5851						
EP_NO: N/A						
Repair Type: Non-Urgent						
Crossing Status: Found						
UCIP Comments: No permit identified for this crossing. Pipe open on WS slope.						
FIELD_STRUCT_DESC: 0.75-inch polyvinyl chloride (PVC) water line through the levee, 1.5 feet below the crown. Hose bib on the landside (LS) shoulder.						
FS Date: 6/19/2012 9:50:50 AM

Hosebib on LS slope.

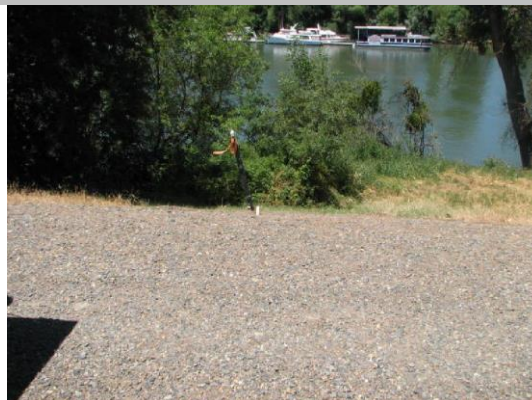
Photo 2 of 3 : UCIP\_FA\_2019\_5851\_8928.jpg

Hosebib on WS slope.

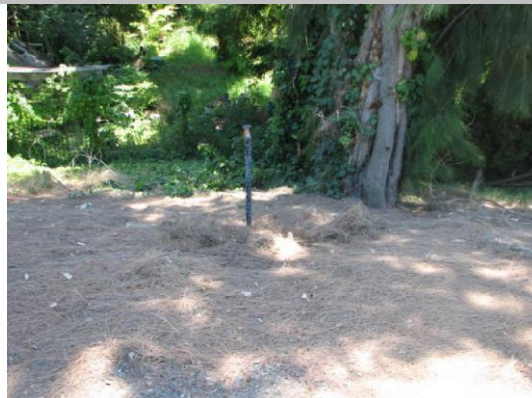
Photo 3 of 3 : UCIP\_FA\_2019\_5851\_8927.jpg

LM Start	1.04	Rating **	M	Issue No.	1783 (cont)	
LM End	1.04	Issue Type +	En	Location *		
Category	Supplemental			GPS Latitude/Longitude		
				Start	End	
Item	DRAFT DWR UCIP Field Study			38.531750 °	38.531750 °	
				-121.525810 °	-121.525810 °	
DWR ID	18905					
Comment Code						
Inspector Comment						
DS_ID:18905 FS_ID:5851 EP_NO: N/A Repair Type: Non-Urgent Crossing Status: Found UCIP Comments: No permit identified for this crossing. Pipe open on WS slope. FIELD_STRUCT_DESC: 0.75-inch polyvinyl chloride (PVC) water line through the levee, 1.5 feet below the crown. Hose bib on the landside (LS) shoulder. FS Date: 6/19/2012 9:50:50 AM

Hosebib on LS slope.

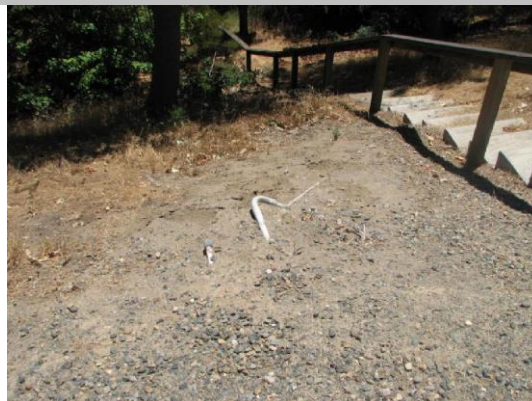
Photo 1 of 2 : UCIP\_FA\_2019\_5852\_8932.jpg

LM Start	1.06	Rating **	M	Issue No.	1784	
LM End	1.06	Issue Type +	En	Location *		
Category	Supplemental			GPS Latitude/Longitude		
				Start	End	
Item	DRAFT DWR UCIP Field Study			38.531650 °	38.531650 °	
				-121.526100 °	-121.526100 °	
DWR ID	18906					
Comment Code						
Inspector Comment						
DS_ID:18906 FS_ID:5852 EP_NO: N/A Repair Type: Non-Urgent Crossing Status: Found UCIP Comments: No permit identified for this crossing. FIELD_STRUCT_DESC: 0.75-inch polyvinyl chloride (PVC) water line through the levee, 1.5 feet below the crown. Hose bib on the waterside (WS) shoulder. Water line located 4 feet upstream of concrete stairs on the landside (LS) slope. (Permit No. 3580, 1961 - Owen L. Perdue). FS Date: 6/19/2012 9:57:16 AM

Pipe on LS slope 4-feet upstream from concrete stairs.

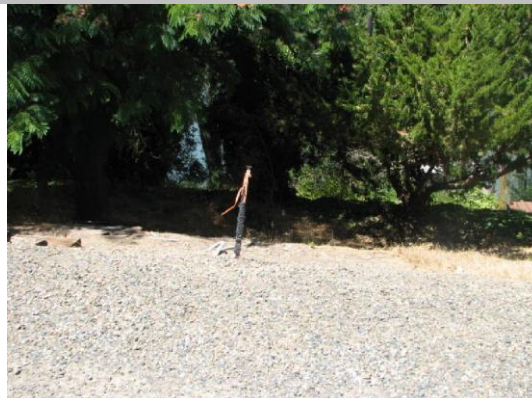
Photo 2 of 2 : UCIP\_FA\_2019\_5852\_8931.jpg

LM Start	1.06	Rating **	M	Issue No.	1784 (cont)	
LM End	1.06	Issue Type +	En	Location *		
Category	Supplemental			GPS Latitude/Longitude		
				Start	End	
Item	DRAFT DWR UCIP Field Study			38.531650 °	38.531650 °	
				-121.526100 °	-121.526100 °	
DWR ID	18906					
Comment Code						
Inspector Comment						
DS_ID:18906 FS_ID:5852 EP_NO: N/A Repair Type: Non-Urgent Crossing Status: Found UCIP Comments: No permit identified for this crossing. FIELD_STRUCT_DESC: 0.75-inch polyvinyl chloride (PVC) water line through the levee, 1.5 feet below the crown. Hose bib on the waterside (WS) shoulder. Water line located 4 feet upstream of concrete stairs on the landside (LS) slope. (Permit No. 3580, 1961 - Owen L. Perdue). FS Date: 6/19/2012 9:57:16 AM

Hose bib on WS shoulder.

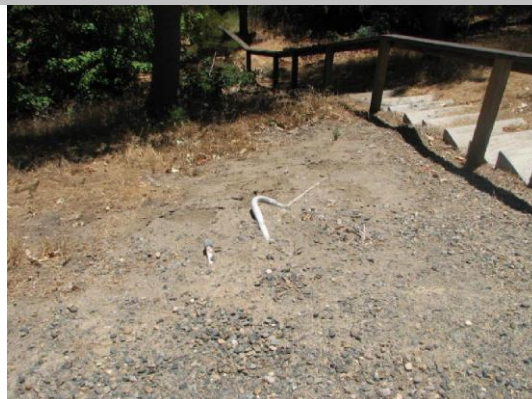
Photo 1 of 2 : UCIP\_FA\_2019\_5857\_8942.jpg

LM Start	1.06	Rating **	M	Issue No.	1785	
LM End	1.06	Issue Type +	En	Location *		
Category	Supplemental			GPS Latitude/Longitude		
				Start	End	
Item	DRAFT DWR UCIP Field Study			38.531630 °	38.531630 °	
				-121.526100 °	-121.526100 °	
DWR ID	18907					
Comment Code						
Inspector Comment						
DS_ID:18907						
FS_ID:5857						
EP_NO: N/A						
Repair Type: Non-Urgent						
Crossing Status: Found						
UCIP Comments: No permit identified for this crossing.						
FIELD_STRUCT_DESC: 1-inch polyvinyl chloride (PVC) electrical conduit through the levee, 1.5 feet below the crown.						
FS Date: 6/19/2012 10:00:00 AM

Electrical conduit on LS slope.

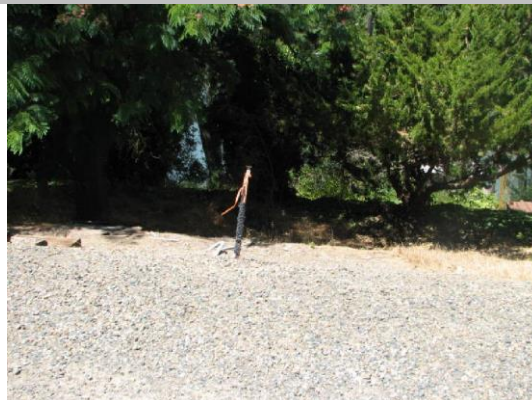
Photo 2 of 2 : UCIP\_FA\_2019\_5857\_8941.jpg

LM Start	1.06	Rating **	M	Issue No.	1785 (cont)	
LM End	1.06	Issue Type +	En	Location *		
Category	Supplemental			GPS Latitude/Longitude		
				Start		End
Item	DRAFT DWR UCIP Field Study			38.531630 °		38.531630 °
				-121.526100 °		-121.526100 °
DWR ID	18907					
Comment Code						
Inspector Comment						
DS_ID:18907						
FS_ID:5857						
EP_NO: N/A						
Repair Type: Non-Urgent						
Crossing Status: Found						
UCIP Comments: No permit identified for this crossing.						
FIELD_STRUCT_DESC: 1-inch polyvinyl chloride (PVC) electrical conduit through the levee, 1.5 feet below the crown.						
FS Date: 6/19/2012 10:00:00 AM

Electrical conduit on WS slope.

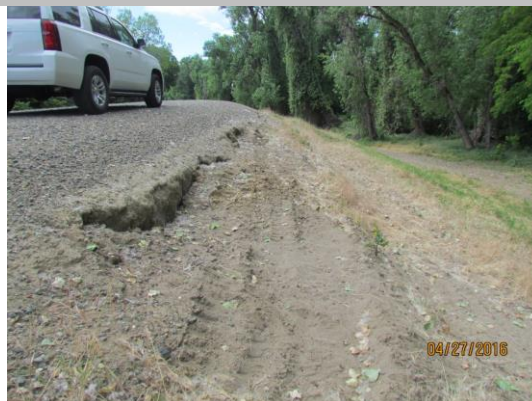
Photo 2 of 2 : FA\_2019\_MA0009\_201\_312\_20190904\_00217.jpg

LM Start	1.27	Rating **	M	Issue No.	312
LM End	1.28	Issue Type +	Ma	Location *	WS
Category	Earthen Levee			GPS Latitude/Longitude	
				Start	End
Item	Erosion / Bank Caving			38.529798 °	38.529679 °
				-121.528808 °	-121.528858 °
DWR ID	DWR_MA0009_01_f_2015_312				
Comment Code					
E2 : Schedule repair of erosion site prior to the next inspection.					
Inspector Comment					
Repair erosion on WS of the levee.

View of the erosion on the waterward side of the levee looking downstream. Erosion is below the shoulder of the levee. Spring 2016.

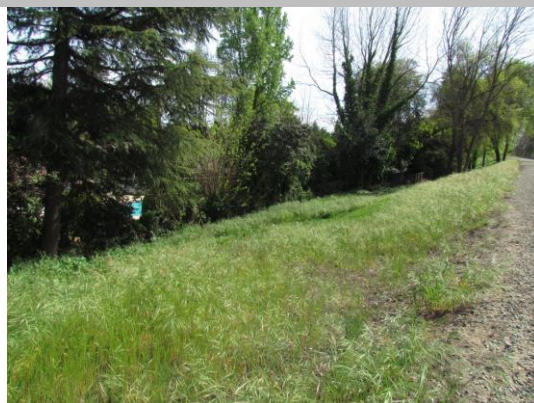
Photo 1 of 1 : FA\_2019\_MA0009\_201\_34\_20190904\_00010.jpg

LM Start	1.29	Rating **	M	Issue No.	34
LM End	1.33	Issue Type +	En	Location *	LS
Category	Earthen Levee			GPS Latitude/Longitude	
				Start	End
Item	Vegetation			38.529468 °	38.528930 °
				-121.528823 °	-121.528820 °
DWR ID	DWR_MA0009_01_s_2012_34				
Comment Code					
V6 : Landscaping					
Inspector Comment					
Trees need to be thinned and trimmed for visibility.

View of vegetation on the landward side of the levee looking downstream. Spring 2015.

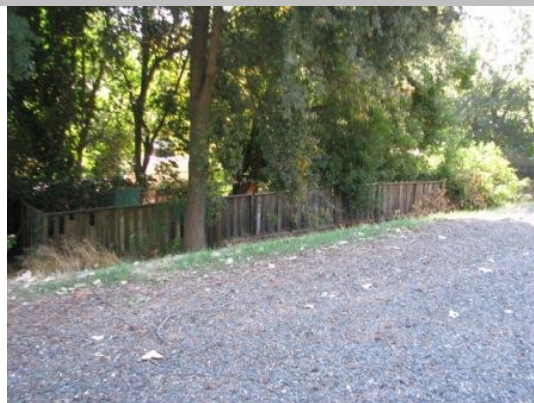
Photo 1 of 1 : FA\_2019\_MA0009\_201\_36\_20190904\_00012.jpg

LM Start	1.33	Rating **	M	Issue No.	36
LM End	1.34	Issue Type +	En	Location *	LS
Category	Earthen Levee			GPS Latitude/Longitude	
				Start	End
Item	Encroachments			38.528913 °	38.528727 °
				-121.528818 °	-121.528809 °
DWR ID	DWR_MA0009_01_s_2012_36				
Comment Code					
FE : Fence					
Inspector Comment					
The wooden fence does not appear to be authorized.

A wooden fence is within the easement of the levee. Fall 2013

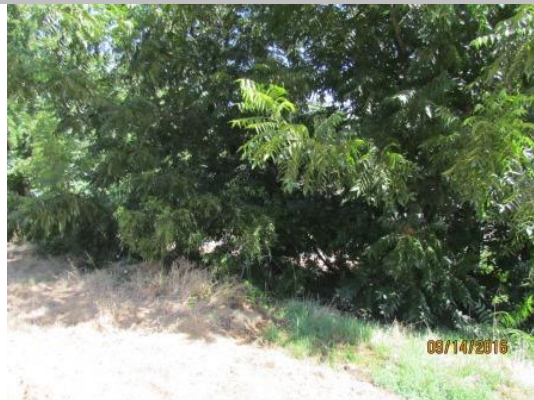
Photo 1 of 2 : FA\_2019\_MA0009\_201\_241\_20190904\_00164.jpg

LM Start	1.37	Rating **	M	Issue No.	241
LM End	1.37	Issue Type +	En	Location *	LS
Category	Earthen Levee			GPS Latitude/Longitude	
				Start	End
Item	Vegetation			38.528255 °	38.528255 °
				-121.528800 °	-121.528800 °
DWR ID	DWR_MA0009_01_f _ 2016_241				
Comment Code					
V6 : Landscaping					
Inspector Comment					
Clear ivy groundcover.

Irrigation system provides water to vegetation on landside slope. Fall 2016 inspection.

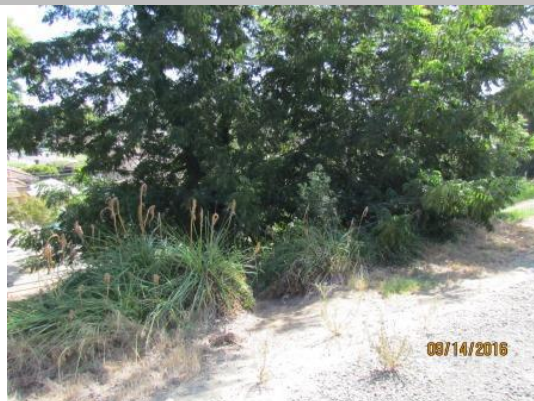
Photo 2 of 2 : FA\_2019\_MA0009\_201\_241\_20190904\_00165.jpg

Irrigation system provides water to vegetaion on landside slope. Fall 2016 inspection. Another view.

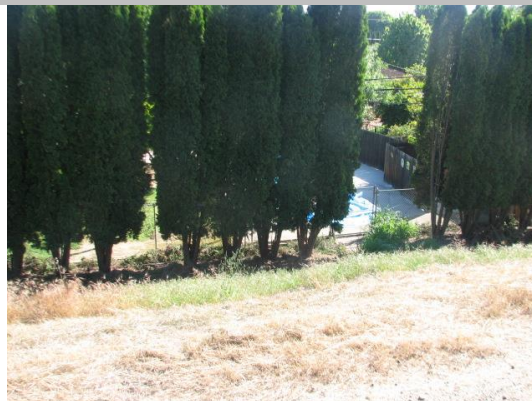
Photo 1 of 2 : FA\_2019\_MA0009\_201\_39\_20190904\_00013.jpg

LM Start	1.60	Rating **	M	Issue No.	39
LM End	1.62	Issue Type +	En	Location *	LS
Category	Earthen Levee			GPS Latitude/Longitude	
				Start	End
Item	Vegetation			38.525471 °	38.525368 °
				-121.526625 °	-121.526440 °
DWR ID	DWR_MA0009_01_s_2012_39				
Comment Code					
V6 : Landscaping					
Inspector Comment					
Cypress trees are blocking visibility on the landward side.

The cypress have been trimmed but still partially block visibility. Spring 2014

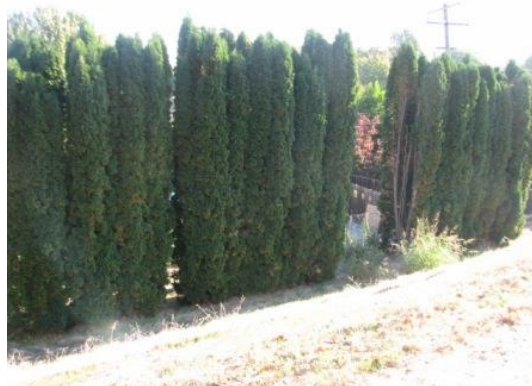
Photo 2 of 2 : FA\_2019\_MA0009\_201\_39\_20190904\_00014.jpg

LM Start	1.60	Rating **	M	Issue No.	39 (cont)	
LM End	1.62	Issue Type +	En	Location *	LS	
Category	Earthen Levee			GPS Latitude/Longitude		
				Start	End	
Item	Vegetation			38.525471 °	38.525368 °	
				-121.526625 °	-121.526440 °	
DWR ID	DWR_MA0009_01_s_2012_39					
Comment Code						
V6 : Landscaping						
Inspector Comment						
Cypress trees are blocking visibility on the landward side.

The tall hedge blocks visibility. Fall 2013

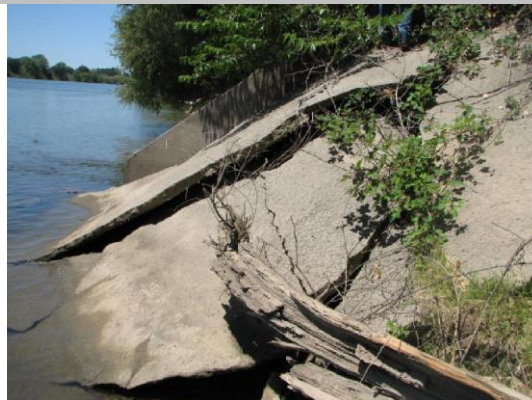
Photo 1 of 3 : UCIP\_FA\_2019\_4703\_6128.jpg

06/19/2012 Concrete around outlet broken up on both downstream and upstream side of outlet. Needs some repairs to prevent further damage. (DWR UCIP - W. Wylie)

Broken up concrete apron on downstream side of outlet

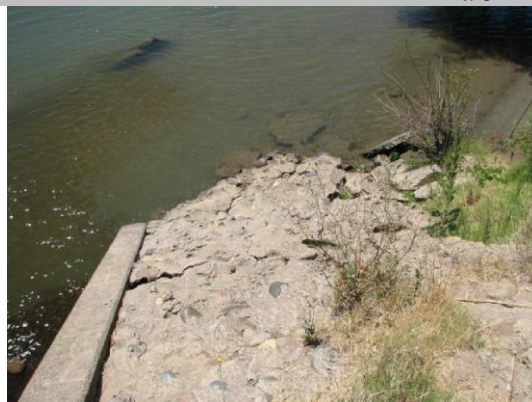
Photo 2 of 3 : UCIP\_FA\_2019\_4703\_6127.jpg

Broken up concrete apron on upstream side of outlet

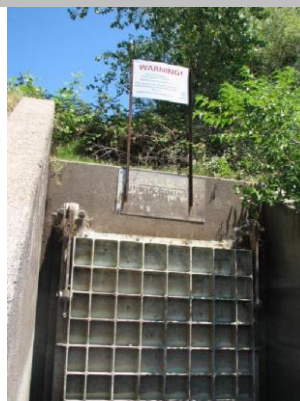
Photo 3 of 3 : UCIP\_FA\_2019\_4703\_6126.jpg

Comment Code						
Inspector Comment						
DS_ID:17408 FS_ID:4703 EP_NO: 5304A Repair Type: Non-Urgent Crossing Status: Found UCIP Comments: 06/06/2017 Received documentation from the City of Sacramento indicating that this crossing was internally inspected on 02/02/2012, PACP Sewer Report was provided. No additional information was received from the City of Sacramento. Need to request evaluation of pipe (integrity of pipe section through the levee) and find out when the City is planning the next internal inspection for this pipe. (DWR UCIP - O. Magana)						
06/19/2012 Concrete around outlet broken up on both downstream and upstream side of outlet. Needs some repairs to prevent further damage. (DWR UCIP - W. Wylie) FIELD_STRUCT_DESC: [Sump No. 140] 8-foot by 8-foot reinforced concrete box drainage culvert through the levee, 28.9 feet below the crown. Pumps are located at the 35th Avenue sewage treatment plant. Concrete gate riser box is located on the waterside (WS) shoulder. Concrete headwall and flap gate on the WS end. (108-inch pipe authorized under Permit No. 5304, 1966 - City of Sacramento). [Additional Reference(s): DWR Levee Log, 1991. USACE Sacramento O&M Manual Unit 115, East Levee of Sacramento River From Sutterville Road to North Boundary of Reclamation District No. 744, February 1955, (Station 290+90, 78-inch diam steel pipe)] FS Date: 6/19/2012 2:20:32 PM

Flap Gate

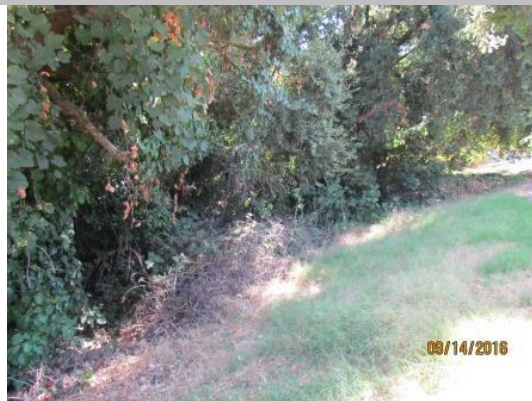
Photo 1 of 2 : FA\_2019\_MA0009\_201\_41\_20190904\_00016.jpg

LM Start	1.87	Rating **	M	Issue No.	41
LM End	1.90	Issue Type +	En	Location *	LS
Category	Earthen Levee			GPS Latitude/Longitude	
				Start	End
Item	Vegetation			38.522864 °	38.522507 °
				-121.523062 °	-121.522667 °
DWR ID	DWR_MA0009_01_s _ 2012_41				
Comment Code					
V6 : Landscaping					
Inspector Comment					
Trees need to be thinned and trimmed for visibility.

Trees on landward side of the levee. Lack of visibility. Fall 2016 inspection.

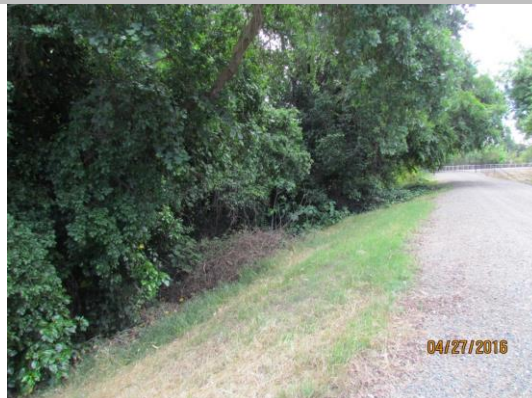
Photo 2 of 2 : FA\_2019\_MA0009\_201\_41\_20190904\_00017.jpg

LM Start	1.87	Rating **	M	Issue No.	41 (cont)	
LM End	1.90	Issue Type +	En	Location *	LS	
Category	Earthen Levee			GPS Latitude/Longitude		
				Start		End
Item	Vegetation			38.522864 °		38.522507 °
				-121.523062 °		-121.522667 °
DWR ID	DWR_MA0009_01_s_2012_41					
Comment Code						
V6 : Landscaping						
Inspector Comment						
Trees need to be thinned and trimmed for visibility.

View of the trees blocking visibility on the landward side looking downstream. Spring 2016.

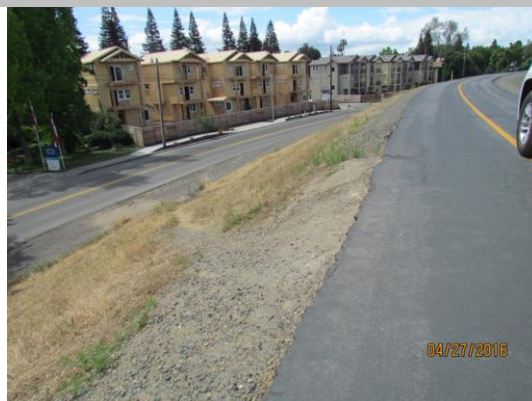
Photo 1 of 1 : FA\_2019\_MA0009\_201\_313\_20190904\_00218.jpg

LM Start	2.18	Rating **	M	Issue No.	313
LM End	2.18	Issue Type +	Ma	Location *	LS
Category	Earthen Levee			GPS Latitude/Longitude	
				Start	End
Item	Slope Stability			38.518878°	38.518878°
				-121.524288°	-121.524288°
DWR ID	DWR_MA0009_01_s_2016_313				
Comment Code					
S2 : Repair the levee slope damaged by foot traffic and prevent access where possible.					
Inspector Comment

View of the slope stability on the landward side of the levee looking downstream. Spring 2016.

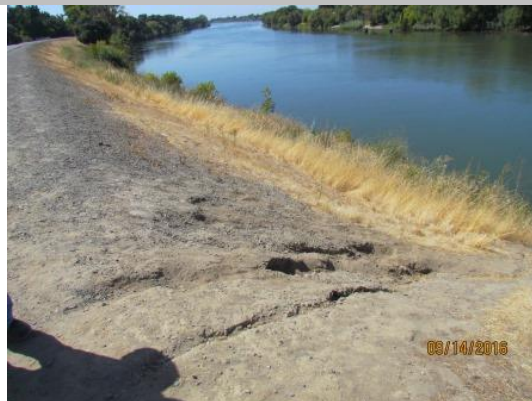
Photo 1 of 1 : FA\_2019\_MA0009\_201\_243\_20190904\_00167.jpg

LM Start	2.28	Rating **	M	Issue No.	243
LM End	2.28	Issue Type +	Ma	Location *	WS
Category	Earthen Levee			GPS Latitude/Longitude	
				Start	End
Item	Erosion / Bank Caving			38.517942 °	38.517942 °
				-121.525612 °	-121.525612 °
DWR ID	DWR_MA0009_01_f_2016_243				
Comment Code					
E2 : Schedule repair of erosion site prior to the next inspection.					
Inspector Comment					
Repair erosion from runoff.

View of erosion site on waterward slope of the levee. Fall 2016 inspection.

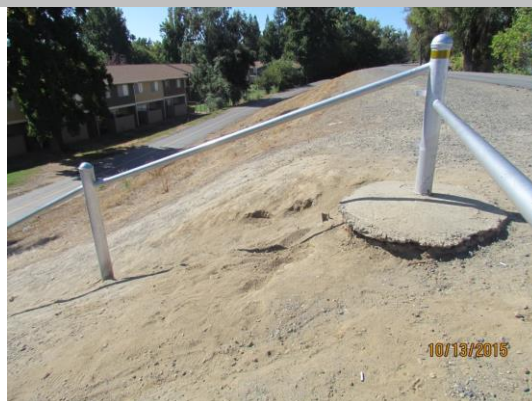
Photo 1 of 2 : FA\_2019\_MA0009\_201\_323\_20190904\_00222.jpg

LM Start	2.40	Rating **	M	Issue No.	323
LM End	2.40	Issue Type +	Ma	Location *	LS
Category	Earthen Levee			GPS Latitude/Longitude	
				Start	End
Item	Slope Stability			38.517131°	38.517131°
				-121.527568°	-121.527568°
DWR ID	DWR_MA0009_01_f_2015_323				
Comment Code					
S2 : Repair the levee slope damaged by foot traffic and prevent access where possible.					
Inspector Comment

View of the the slope stability on the landward side of the levee looking downstream. Fall 2015.

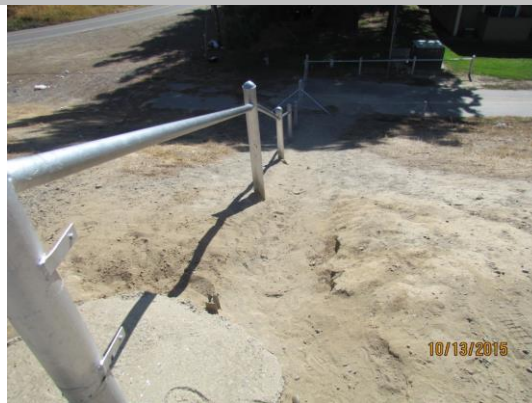
Photo 2 of 2 : FA\_2019\_MA0009\_201\_323\_20190904\_00223.jpg

LM Start	<b>2.40</b>	Rating **	M	Issue No.	<b>323 (cont)</b>
LM End	<b>2.40</b>	Issue Type +	Ma	Location *	LS

Additional view of slope stability. Fall 2015.

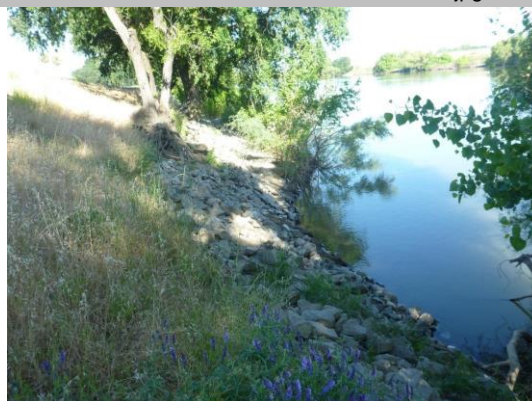
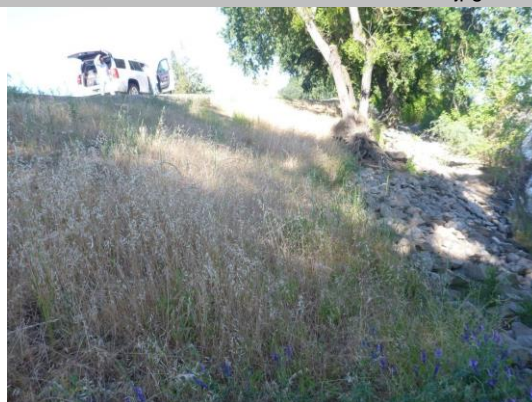
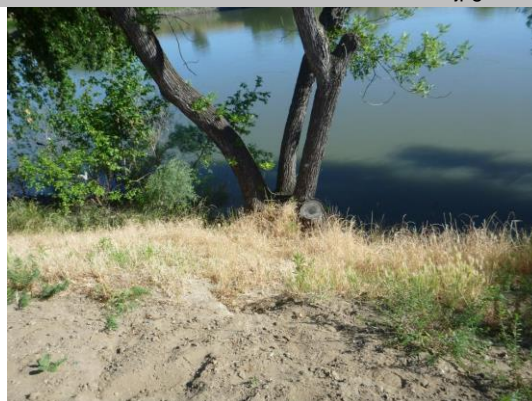
LM Start	2.51	Rating **	A/W	Issue No.	230
LM End	2.52	Issue Type +	Ma	Location *	
Category	Supplemental			GPS Latitude/Longitude	
				Start	End
Item	2017 Storm Damage			38.516660 °	38.516653 °
				-121.529538 °	-121.529645 °
DWR ID	LMA-63				
Comment Code					
Inspector Comment					
Levee Evaluation Comments					
Description:					
Site ID No:230					
Site Designation:LMA-63					
Repair Type: Erosion					
Rating: Area of Concern					
Field Date:2/10/2017					
Notes: Oversized section of levee with rip rap on the waterside slope.					
Little damage visible.

LM Start	2.51	Rating **	A/W	Issue No.	230 (cont)	
LM End	2.52	Issue Type +	Ma	Location *		
Category	Supplemental			GPS Latitude/Longitude		
				Start		End
Item	2017 Storm Damage			38.516660 °		38.516653 °
				-121.529538 °		-121.529645 °
DWR ID	LMA-63					
Comment Code						
Inspector Comment						
Levee Evaluation Comments						
Description:						
Site ID No:230						
Site Designation:LMA-63						
Repair Type: Erosion						
Rating: Area of Concern						
Field Date:2/10/2017						
Notes: Oversized section of levee with rip rap on the waterside slope.						
Little damage visible.

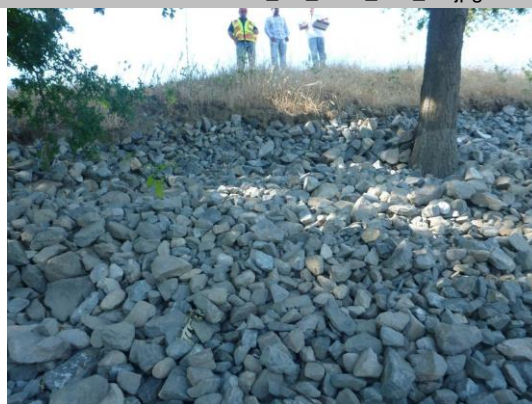
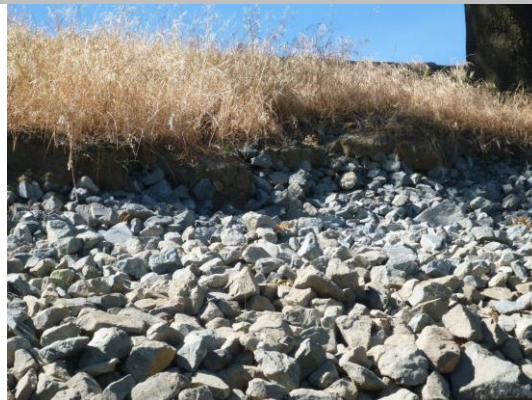
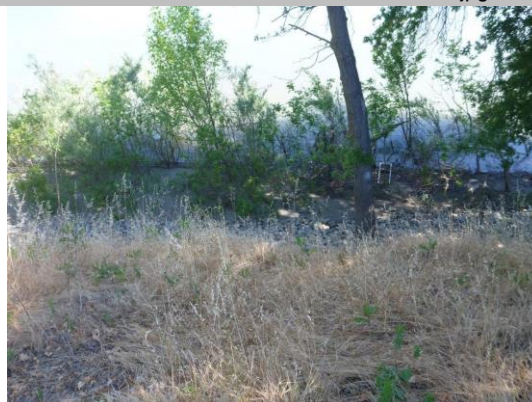
LM Start	2.57	Rating **	A/W	Issue No.	231
LM End	2.58	Issue Type +	Ma	Location *	
Category	Supplemental			GPS Latitude/Longitude	
				Start	End
Item	2017 Storm Damage			38.516444 °	38.516442 °
				-121.530639 °	-121.530677 °
DWR ID	LMA-64				
Comment Code					
Inspector Comment					
Levee Evaluation Comments					
Description:					
Site ID No:231					
Site Designation:LMA-64					
Repair Type: Erosion					
Rating: Area of Concern					
Field Date:6/2/2017					
Notes: The crown of this levee is well over 60 feet, and newly placed riprap is on the waterside slope. Minor damage visible. Fall 2019 DWR Inspection: Riprap at the waterside toe remains intact.

LM Start	2.57	Rating **	A/W	Issue No.	231 (cont)
LM End	2.58	Issue Type +	Ma	Location *	
Category	Supplemental			GPS Latitude/Longitude	
				Start	End
Item	2017 Storm Damage			38.516444 °	38.516442 °
				-121.530639 °	-121.530677 °
DWR ID	LMA-64				
Comment Code					
Inspector Comment					
Levee Evaluation Comments					
Description:					
Site ID No:231					
Site Designation:LMA-64					
Repair Type: Erosion					
Rating: Area of Concern					
Field Date:6/2/2017					
Notes: The crown of this levee is well over 60 feet, and newly placed riprap is on the waterside slope. Minor damage visible. Fall 2019 DWR Inspection: Riprap at the waterside toe remains intact.
